RE: Ponderosa Ranch of Pointe Coupee Mitigation Bank, Pointe Coupee Parish, Louisiana, Final MBI Submittal (MVN-2011-03213).

Ponderosa Ranch

of Pointe Coupee Mitigation Bank

Mitigation Banking Instrument

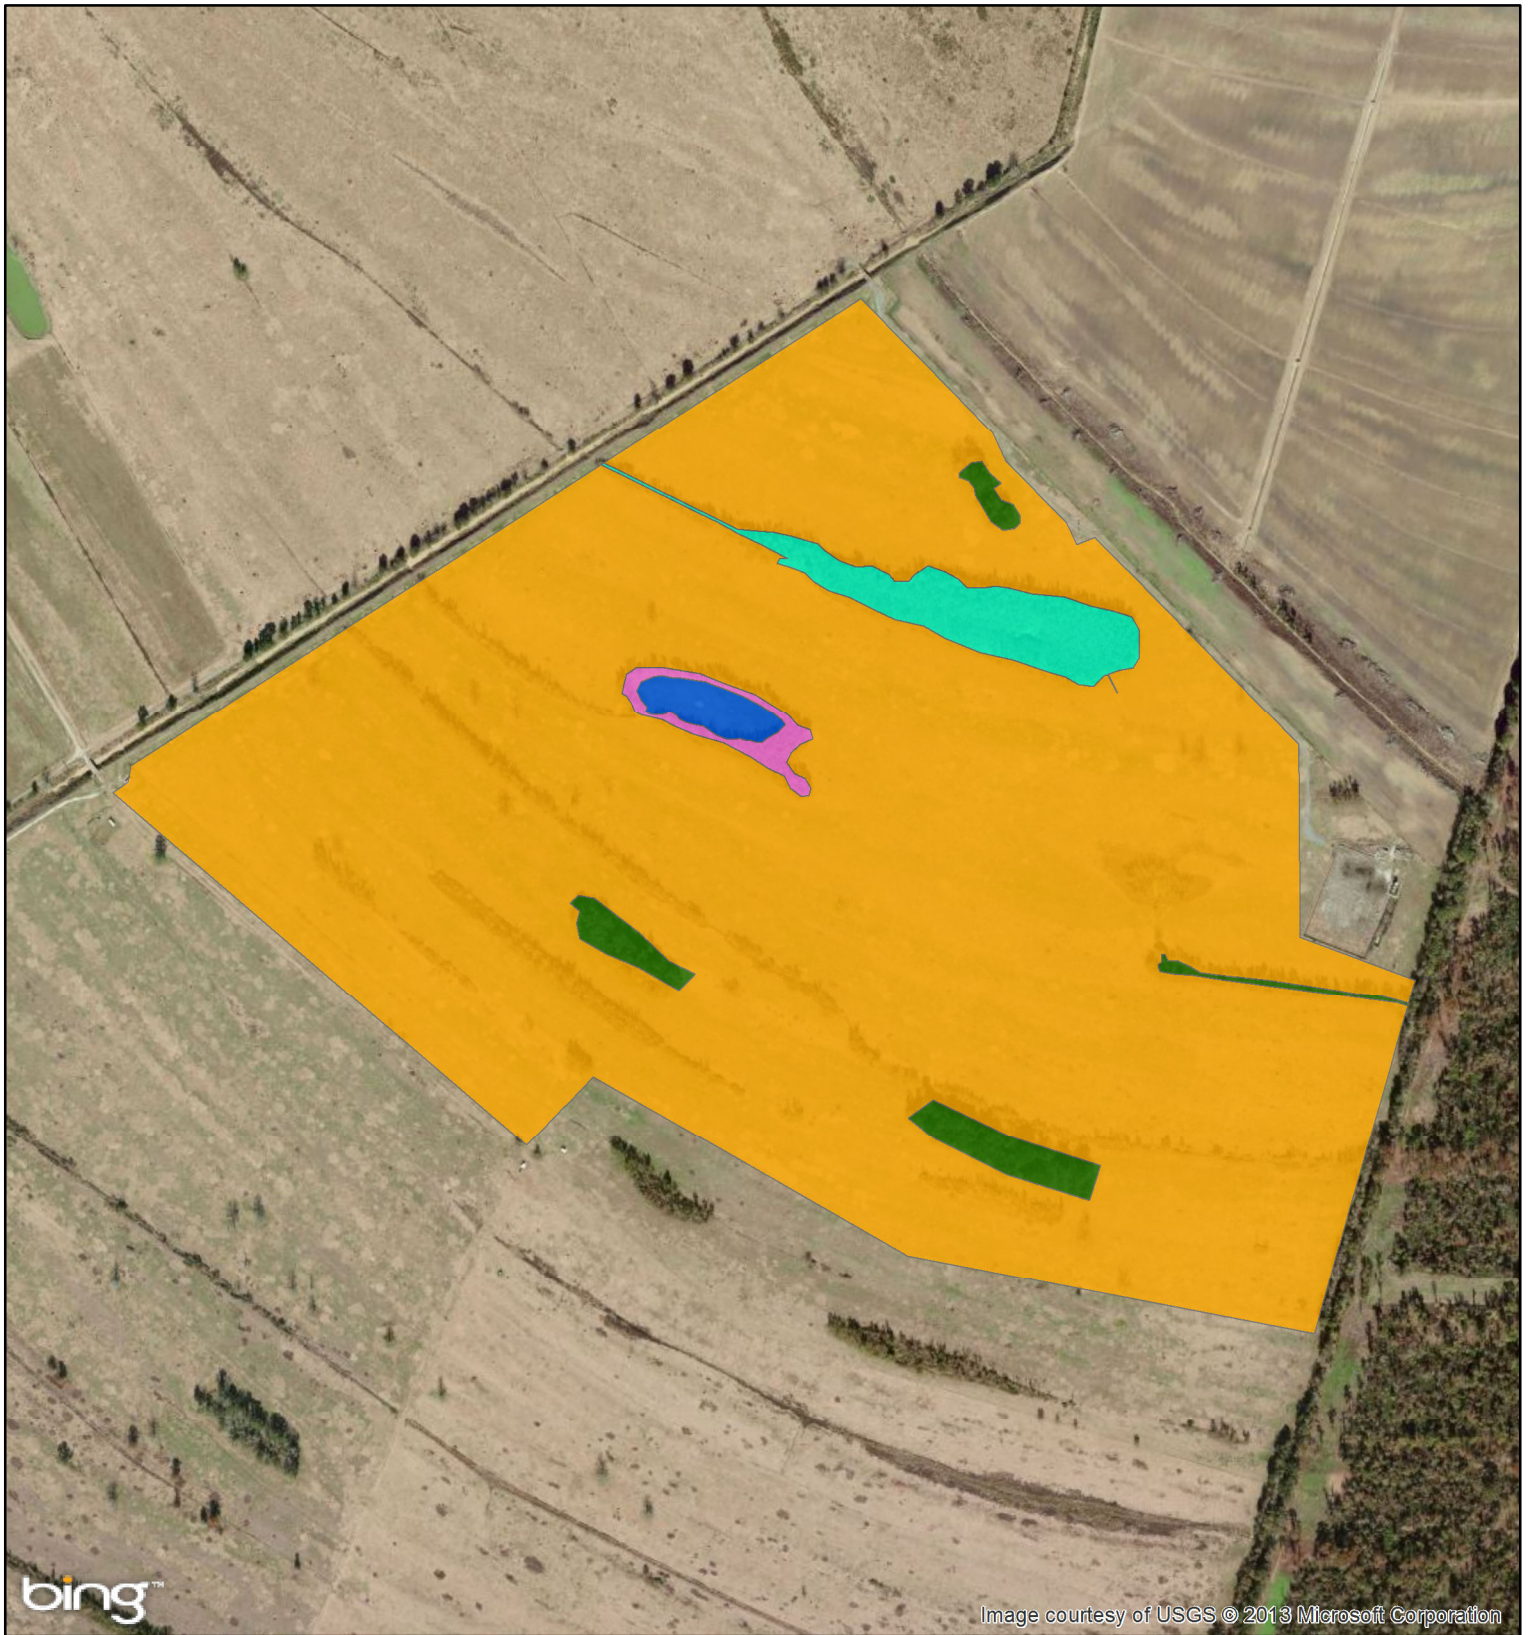
FIGURE 9

- Improved Pasture (304.0 Acres)
- Bottomland Hardwood Forest (6.1 Acres)
- Chinese Tallow Forest (9.2 Acres)
- Black Willow Forest (2.1 Acres)
- Open Water (2.4 Acres)

PRE-RESTORATION CONDITIONS

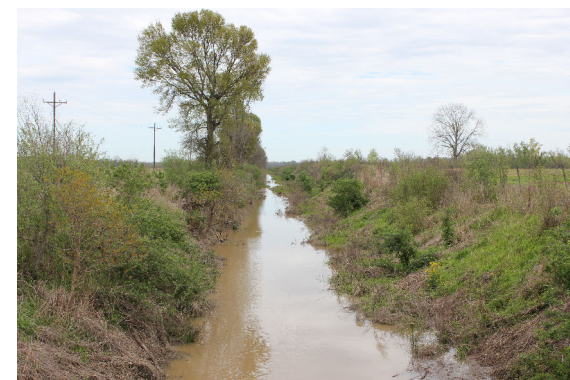
Photo taken 3/10/2012

Existing Cross-Section On March 23, 2012
